BELZONA REPAIRS EBONITE LINING IN PROCESS VESSEL

ID: 3414

Customer Location: International chemical company, Spain
Application Date: April 2012

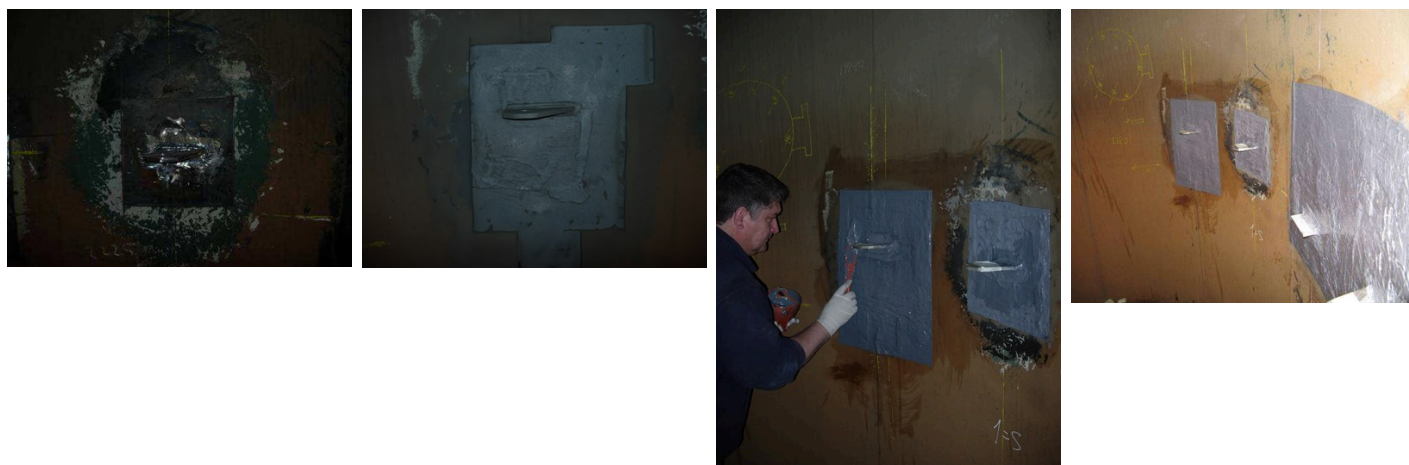
Photograph Descriptions

The internal ebonite lining was damaged around the vessel support areas where the ebonite had disbonded leaving the steel exposed.

- * Ebonite lining damaged around support areas ,
- * Surface preparation completed ,
- * Belzona® 4301 being applied on the internal supports areas ,
- * Completed application ,

The application was carried out in accordance with Belzona Know-How System Leaflet TCC-3. The surface was prepared removing the previous mastic products. Then, the ebonite was roughened using a grinder and the whole application area was grit blasted to ensure a minimum 75 micron surface profile on the exposed steel before rebuilding all damaged areas with the Belzona® 4301.

This application was carried out in-situ, repairing the ebonite lining without the requirement of a vulcanization process, and minimising downtime and disruptions to the client facilities and operations.
