BELZONA SEALS SPY GLASSES IN VESSEL

ID: 3415

Customer Location: International chemical company, Spain
Application Date: April 2012

Two spy glasses in process vessel (ion exchange).

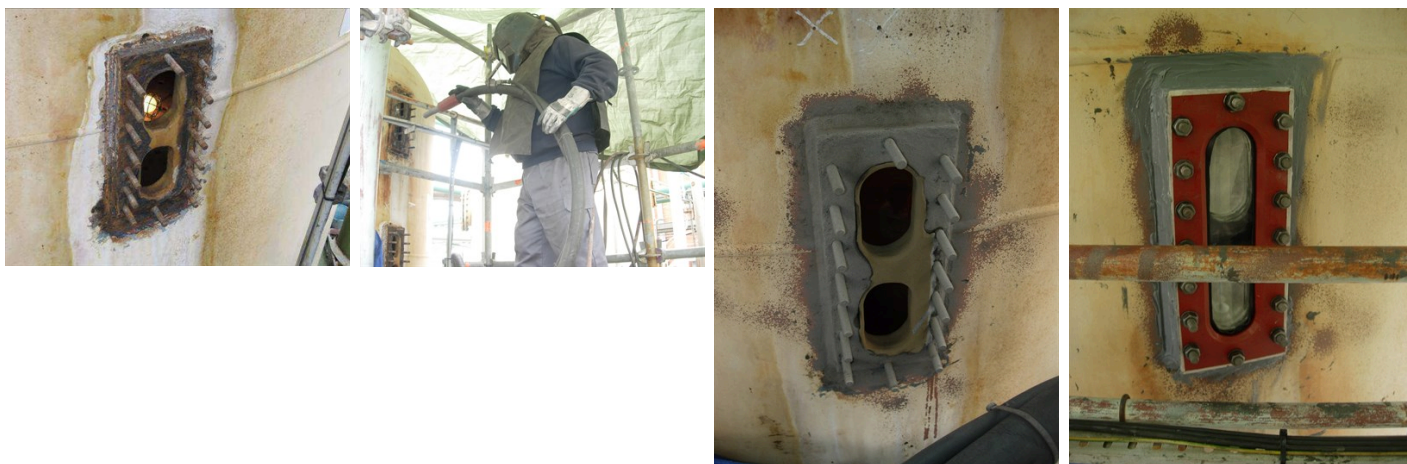
Photograph Descriptions

Corrosion had occurred at the spy glasses caused by the Hydrochloric acid used during the regeneration process.

- * Spy glass before the application ,
- * Grit blasting in progress ,
- * Surface preparation completed ,
- * Application completed ,

The application was carried out in accordance with Belzona Know-How System Leaflet TCC-5. After grit blasting the surface and protecting areas where Belzona should not adhere (nuts, bolts, cover) with two coats of Belzona® 9411 (Release Agent) Belzona® 4301 applied to rebuild lost profiles, restore corrosion protection allowing the site glasses to be effectively sealed. .
