INTERNAL COATING OF SEAWATER LIFT PUMPS

ID: 3418

Customer Location: Workshop Stavanger Norway
Application Date: February 2012

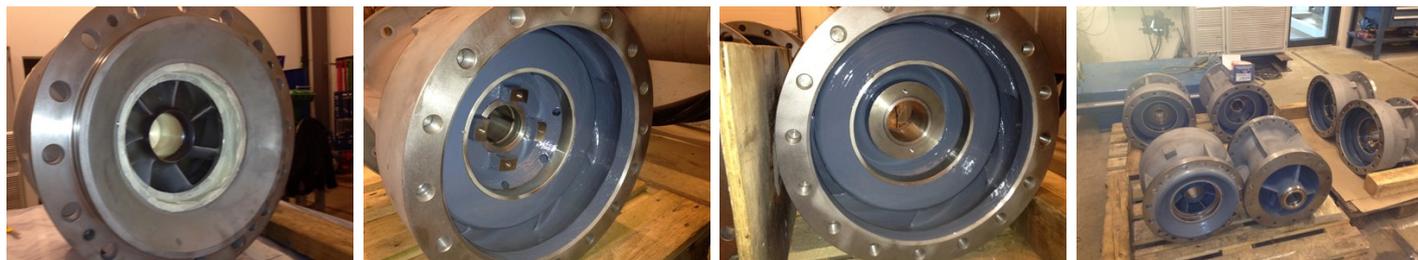
Photograph Descriptions

- * Grit blasted and prepared for coating ,
- * Internal coating ongoing ,
- * Internal coating completed ,
- * Overview of completed application prior to assembly ,

Six new seawater lift pump chambers to be internally protected prior to assembly. The pumps are used for firefighting purposes on a North Sea platform.

Application was carried out in accordance to the Belzona Know-How System Leaflet CEP-1. Following grit blasting, the pumps were coated with 2 layers of Belzona® 1321.
