# BELZONA PROTECTS NEWLY CONSTRUCTED PLANT ROOM

ID: 3419

Customer Location: University, Wolverhampton, UK  
Application Date: May 2012

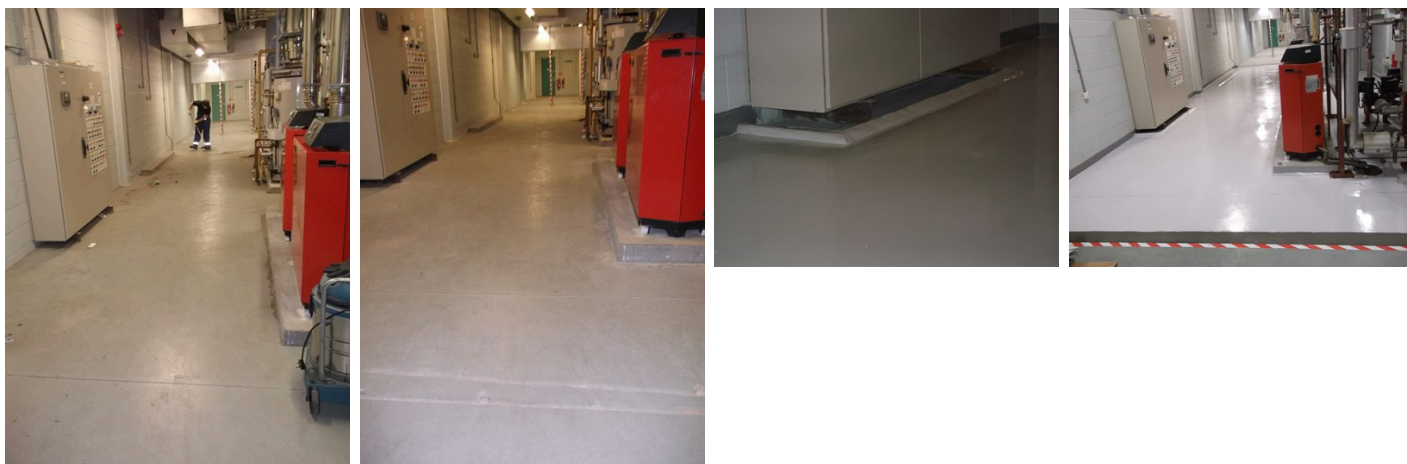
- \* Clearing of plant room floor ,
- \* Floor abraded in preparation for Belzona® 4131 bund and fillets ,
- \* Section of bunded area ,
- \* Completed plant room floor bund after coating with Belzona® 5231 ,

Application was carried out in accordance with Belzona System Leaflets FPA-3 and TCC-15. Belzona® 4131 was used to create raised bunded areas and covings before applying Belzona® 5231 to completely seal the floor area.

The customer had already experienced floods in other unprotected plant rooms and knew Belzona would be able to create the necessary protection required. The Belzona® 4131 enabled the construction of a raised containment area for spills for sealing with the impermeable Belzona® 5231. This coating has the added benefit of containing a non-slip aggregate improving the safety of the plant room when floor is wet.
