BELZONA REBUILDS AND PROTECTS THIS SUCTION PUMP END PLATE

ID: 342

Customer Location: *Bleached Kraft Paper Mill in Japan*
Application Date: *March 1990*

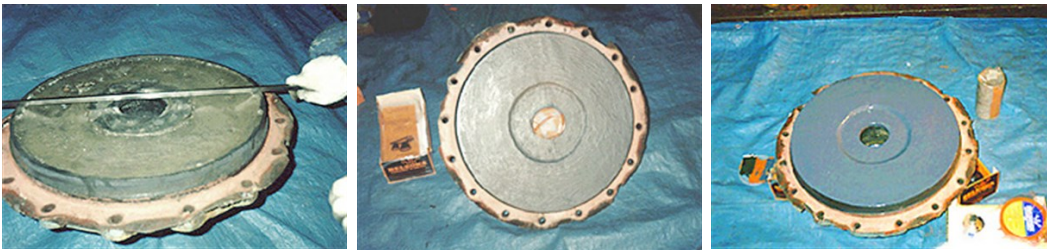
This end suction pump carrying a combination of medium consistency stock, alkaline medium, and chlorine carry over at 70°C, eroded and corroded the end plate of this pump. The pump was no longer able to move the required volume of liquid per batch.

- * End plate metal loss clearly evident ,
- * Rebuilt end plate with Belzona® 1311 (Ceramic R-Metal) ,
- * Resurfaced and final repair with Belzona® 1321 (Ceramic S-Metal) ,

The application was carried out in accordance with Belzona Know-How System Leaflets CEP-3 and CEP-5.
