# EMERGENCY REPAIR OF TYRE AT QUARRY WITH BELZONA

ID: 3426

Industry: Mining & Quarrying  
Application: SHM-Solids Handling Machinery

Tyre on heavy loader operating in quarry

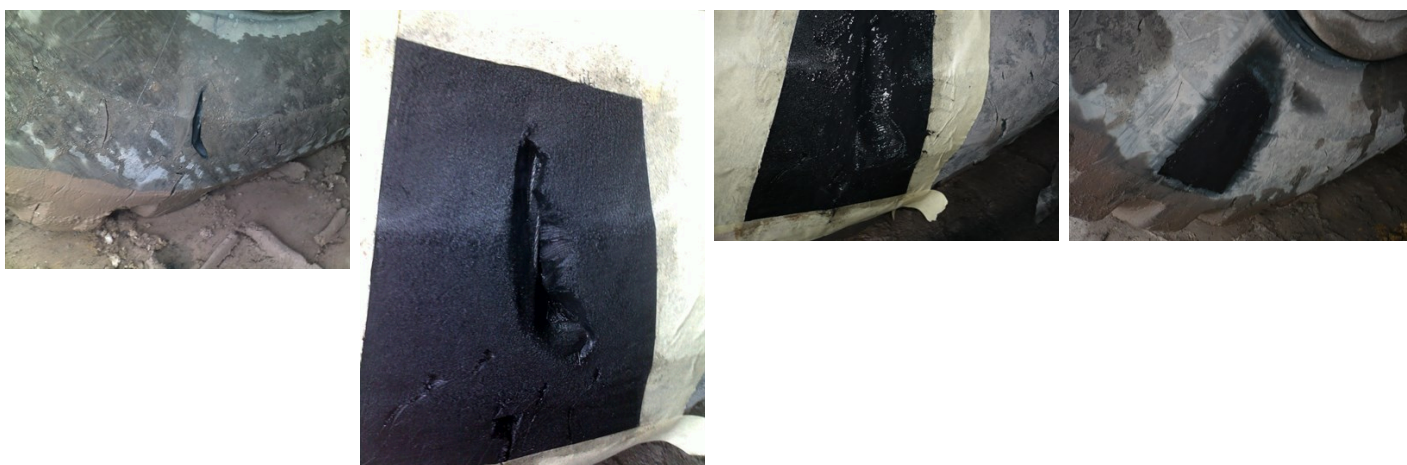
## Photograph Descriptions

The tyre on the loader was damaged by sharp edged rock. Air was leaking when the crack was in bottom position under full load. Customer needed emergency repair so the loader could continue to operate until new tyres could be purchased and installed.

\* Damage in tyre 2 Damaged area prepared and conditioned with Belzona® 2911 Embedding Belzona® 9341 (Reinforcement Tape) into the crack Repaired tyre ready to operate ,

Application was carried out in accordance with Belzona Know-How System Leaflet SHM-9.

The alternative was to hire a subcontractor whilst the loader waited for new tyre to be obtained and fitted. Belzona repair stopped the air leakage and made possible for the loader to operate until new tyre arrived, for the total cost of only two hours of a hired loader!
