# BELZONA REPAIR TO FRANCIS TURBINE END COVER

ID: 3427

**Customer Location:** Hydro power plant, Sweden  
**Application Date:** April 2011

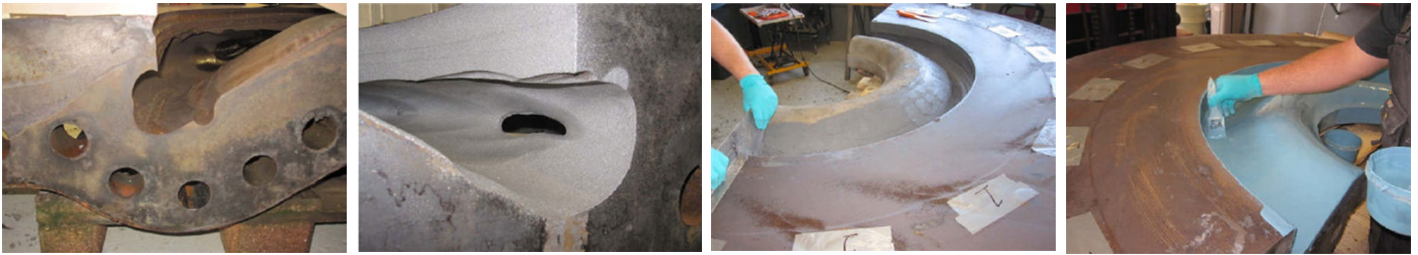
The velocity of the water had led to erosion damage on the end cover of the turbine casing. Several through wall defects were reducing the efficiency of the unit. The end cover was 2.6m wide, 0.2m deep and 1.4 m long

- \* One of the end cover halves (there are 4 in total) ,
- \* View of the end cover after surface preparation. Through wall defects clearly visible ,
- \* A former was used to create the original profiles ,
- \* The application of Belzona® 1341 to complete the repair ,

Application was carried out in accordance with Belzona Know-How System Leaflets CEP-3 & 5. The work was done in the contractor's workshop. After preparing the substrate by grit blasting and sealing holes with Belzona® 1291, Belzona® 1311 was applied up to a total thickness of 5-6 cm to restore original profile (100 kg of Belzona® 1311 was used for the repair on the two turbine ends). Finally two coats of Belzona® 1341 were applied to offer erosion protection and to create a smooth finish.
