# BELZONA KEEPS THIS PASSENGER FERRY RUNNING SMOOTHLY

ID: 345

Rudder horn of large ferry vessel.

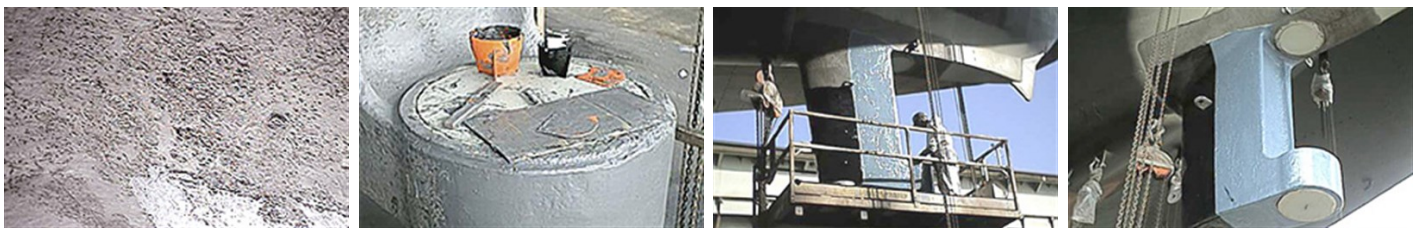
*The sides and trailing surfaces of this large rudder horn suffered from cavitation and significant metal loss.*

- \* Cavitation clearly evident ,
- \* Rebuilding with Belzona® 1121 (Super XL-Metal) ,
- \* Belzona® 2141 being applied ,
- \* Final application ,

The application was carried out in accordance with Belzona Know-How System Leaflets SOS-1 and SOS-2.

Belzona® 2141 has exhibited excellent cavitation resistance as document-ed by the ARL at Penn State. Alternatively, you would have to weld up hundreds of damaged areas or cut out a large section and weld in new plate.
