BELZONA REPAIRS AND PROTECTS A PUMP TRANSPORTING 98% SULFURIC ACID ACID

ID: 346

Customer Location: *Chemical plant in Alabama, U.S.A.*
Application Date: *1992*

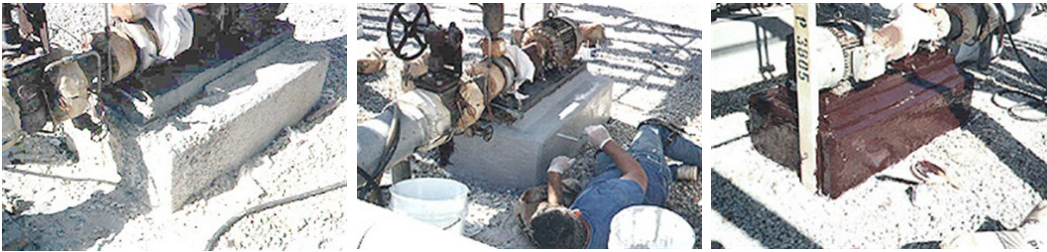
Photograph Descriptions

A pump carrying 98% sulfuric acid was leaking, causing severe deterioration of the concrete base, pump stand and the surrounding containment area.

- * Deteriorated pump base and containment area ,
- * Rebuilding with Belzona® 4131 (Magma Screed) ,
- * Coating with Belzona® 4311 for finished application ,

Deteriorated pump base or plinth.

The application was carried out in accordance with Belzona Know-How System Leaflet TCC-9.

Other coatings were tried previously and failed. The entire containment area was later done due to the performance of the pump base.
