BELZONA SEALS CRACKS IN UNDERWATER CONCRETE TANK

ID: 349

Customer Location: California water plant, U.S.A.
Application Date: 1998

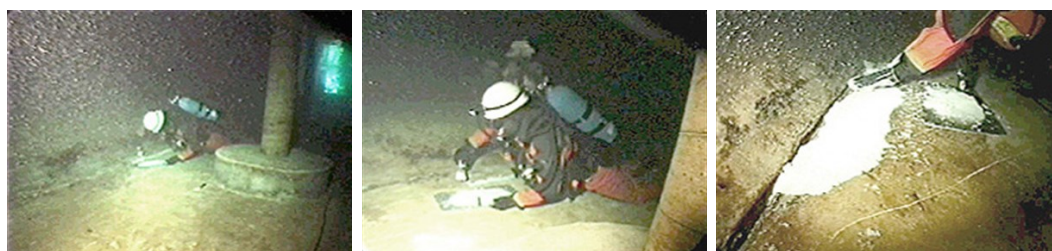
Photograph Descriptions

Various concrete cracks in the base of this aquaduct leaked copious amounts of water.

- * Diver sent down to begin the application ,
- * Diver utilizing a putty knife to force Belzona ® 4111 (Magma Quartz) into concrete cracks ,
- * Large section of spalled concrete repaired ,

Concrete cracks in base of aquaduct.

The aquaduct could not be drained so the only alternative was to do an underwater application. The slurry version of the Belzona ® 4111 (Magma Quartz) can easily wet out the concrete and even though adhesion is reduced, the repair was still a success.
