# BELZONA RESTORES OFFICE FACADE

Application: WPA-Wall Problem Areas

Customer Location: Commercial offices, Sheffield, UK

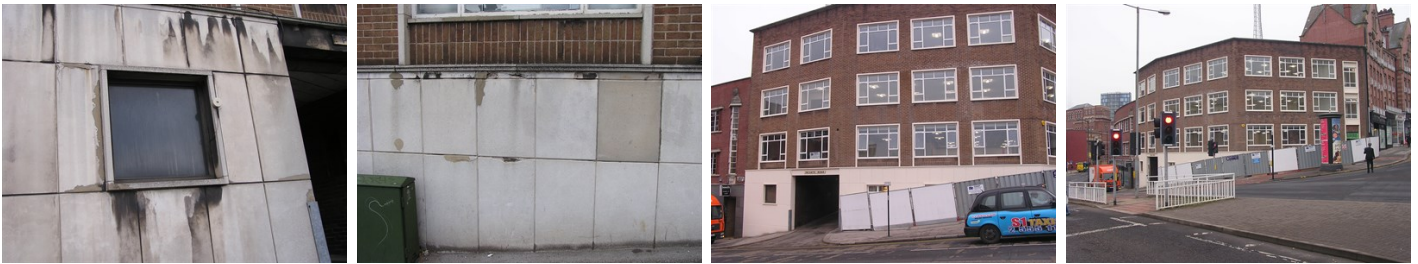
Concrete Panels on the lower section of the building had chipped, spalled and aesthetically degraded over time due to dirt and environmental contaminant staining. Panels surrounding the upper windows had suffered similar damage

- \* Staining of concrete panels with initial small Belzona® 4141 repairs around the window ,
- \* Lower concrete panels during application of Belzona® 4141 ,
- \* Lower sections of the building restored and protected with Belzona® 5151 ,
- \* Finished application ,

The application was carried out in accordance with Belzona Know-How System Leaflets WPA-1 and WPA-4. All damaged concrete surfaces were rebuilt using Belzona® 4141 before being overcoated with Belzona® 5151.
