# BELZONA RESTORES THIS FAN PUMP TO LIKE NEW CONDITION

ID: 350

35,000 GPM Gould's Primary Fan Pump.

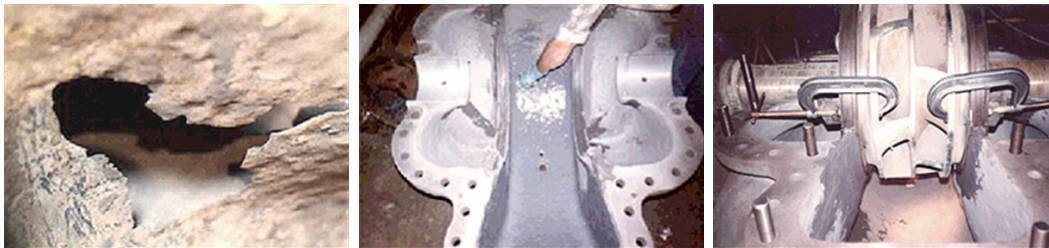
*Extreme graphitization had caused holes between the suction and discharge sides of this fan pump after only four years of operation.*

- \* General view of casing showing graphitization and hole between suction and discharge sides ,
- \* One half of the casing being rebuilt and resurfaced ,
- \* Impeller in position to reform the case rings ,

The application was carried out in accordance with Belzona Know-How System Leaflets CEP-2, CEP-3 and CEP-5.

The complete application from beginning to end took only three days. The pump rehabilitation, including cost of labor, machinery and products was only 15% of the cost of a new casing.
