# BELZONA ENHANCES THIS COAST GUARD CUTTER

ID: 351

Industry: Marine  
Application: SOS-Ships and Offshore Structures

Customer Location: United States Coast Guard.  
Application Date: September 2000

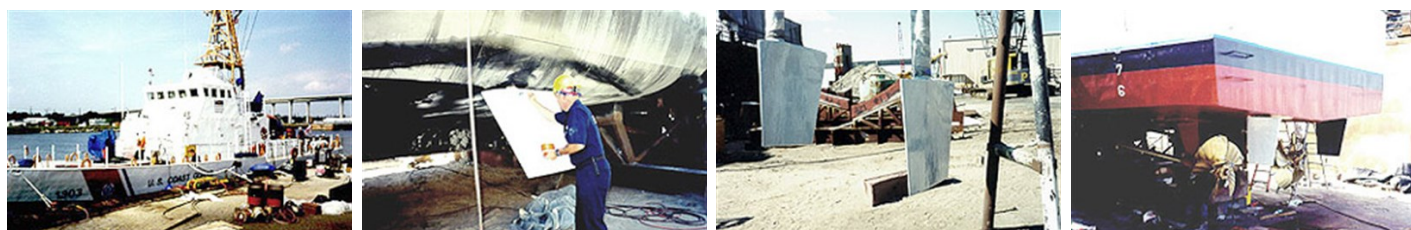
*The rudder and stabilizer assemblies suffer from cavitation and erosion from entrained solids.*

- \* View of the 110' class cutter ,
- \* Application of Belzona ® 1341 to stabilizers ,
- \* Rudders coated ,
- \* Completed application and equipment installed ,

All the stabilizer work was done in place. Two coats of Belzona ® 1341 (Supermetalglide) were applied and allowed to sufficiently cure. A small crane was then brought in and the equipment was then installed. Belzona ® 1341 (Supermetalglide) works well as long as the crew follows a regular cleaning procedure by periodically removing marine growth.
