STARK KORRODIERTES PUMPENGEHÄUSE FÜR FEINPAPIER DANK BELZONA WIE NEU

Industrie: Zellstoff & Papier

Anwendung: Kreiselpumpen

Standort des Kunden: Papierfabrik, Port Elizabeth, Südafrika

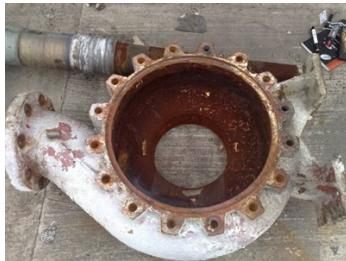
Das Spiralgehäuse wies so schwerwiegende Korrosionsschäden auf, dass es nicht wieder in Betrieb genommen werden konnte.

- * 1. Korrodiertes Spiralgehäuse ,
- * 2. Beschichtung mit Belzona 1321 (Ceramic S -Metal) ,
- * 3. Repariertes und einsatzbereites Spiralgehäuse ,
