# BELZONA SAVES RETIREMENT RESIDENCE OVER \$7,000

Industry: General Industry  
Application: FBC-Fans, Blowers and Compressors

Customer Location: Retirement residence in Florida, U.S.A.  
Application Date: October 1993

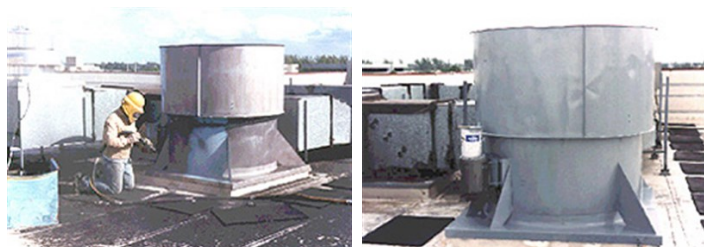
A six foot diameter exhaust fan is used in case of a fire to evacuate smoke from the burning building. The corroded metal shroud developed holes. Rainwater entered through the holes and caused water damage to the inside of the building.

- \* Shroud grit blasted ,
- \* Completed coating with Belzona® 5111 (Ceramic Cladding) ,

The application was carried out in accordance with a Belzona Know-How System Leaflets FBC-2 and FBC-4.

The cost of a new stainless steel shroud was \$9,600. The existing shroud was salvaged with approximately \$600 in products. Including blasting, the customer saved over \$7,000.
