BELZONA REFURBISHES SETTLEMENT TANK AT WATER TREATMENT PLANT

Damaged Primary Settlement Tank (PST) at water authority site

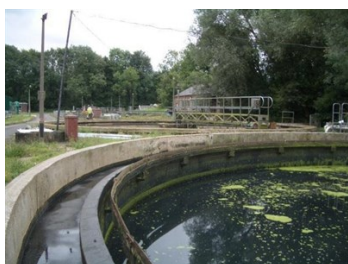
Due to freeze thaw damage and the constant weight of the separator arm, many areas of the running track had become damaged.

- * General view of the PST ,
- * Forming boards being used during application of the Belzona® 4131 ,
- * Expansion joint sealed with Belzona® 2211 ,
- * Completed repair ,

Application was carried out in accordance with Belzona Know-How System Leaflets FPA-1 & FPA-6. Timber formers were fixed to ensure accurate levels were achieved.
