BELZONA® ELIMINATES DAMAGE FROM CUI (CORROSION UNDER INSULATION)

ID: 358

Customer Location: Oil Refinery in U.K.
 Application Date: 2001

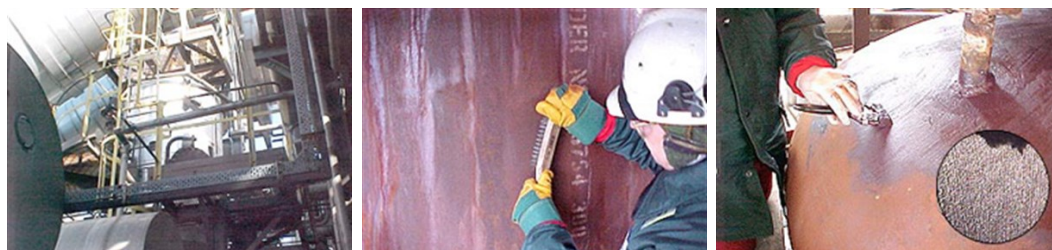
Photograph Descriptions

The vessel was suffering from CUI (Corrosion Under Insulation).

* An overall view of the vessel, complete with lagging, while in service. Surface preparation was carried out via wire brush and power wire-brushing tool. Belzona® 5851 is being applied via brush. Close-up of application area. Showing brush strokes after one year of service. ,

The surface was prepared manually with a wire brush and a power wire brushing tool was used to remove loose particles. Belzona® 5851 was applied by brush. Once the material cured, the vessel was re-lagged.
