BELZONA® PROTECTS FRACTIONATOR TOWER

ID: 359

Customer Location: Refinery in Singapore
Application Date: April 2001

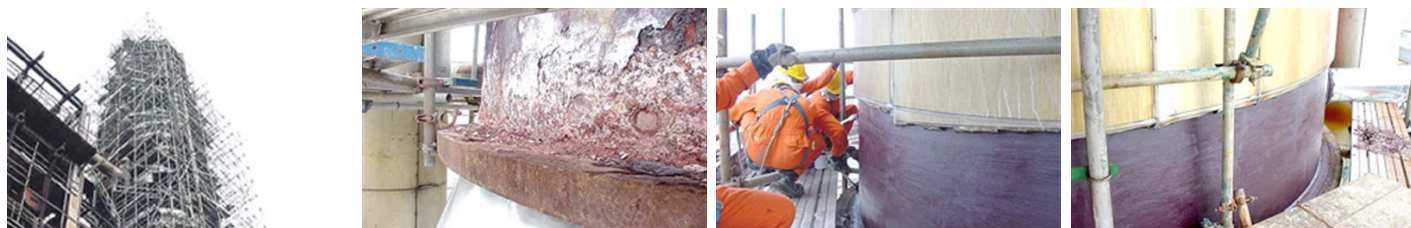
Photograph Descriptions

CUI (Corrosion Under Insulation) particularly around the support rings where moisture had accumulated.

* General view of the tower. The degree of corrosion clearly evident on the support rings. Application underway. Application complete. ,

The application was carried out in accordance with Belzona Know-How System Leaflet TCC-5. The insulation was removed from affected areas, substrate prepared and Belzona® 5851 (HA-Barrier) applied to the hot substrate.

Belzona® 5851 provides excellent corrosion protection to these badly cor-roded areas without interruption to production.
