BELZONA TANK FARM

ID: 36

Industry: Chemical & Petrochemical
Application: TCC-Tanks and Chemical Containment Areas

Customer Location: Chemical Plant in South Alabama, USA
Application Date: August 1995

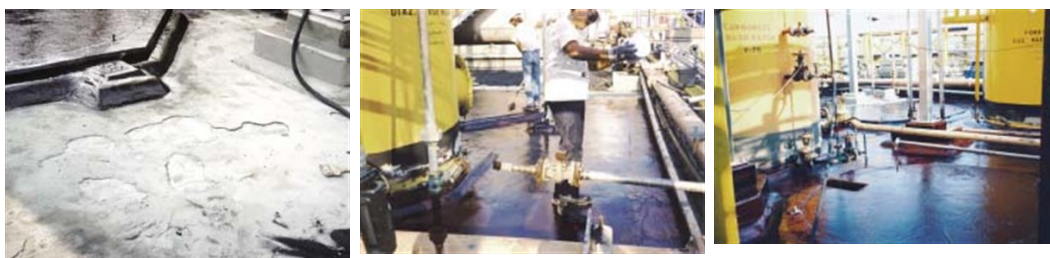
Harsh chemicals attacking existing substrate which was installed in 1993.

- * View of damage to polymeric repair compound ,
- * Application of Belzona® 4311 (Magma CR-1) in progress ,
- * 5000 sq. ft. area protected ,

The previous polymeric concrete repair material was damaged by chemical attack. The concrete was repaired and all areas protected.

Chemical containment area (5000 sq. ft.)

The application was carried out in accordance with Belzona Know-How Leaflets TCC-9 and TCC-15.
