CORRODED PIPEWORK: A THING OF THE PAST WITH BELZONA® 5851 (HA-BARRIER)

ID: 361

Customer Location: Oil refinery in New Zealand

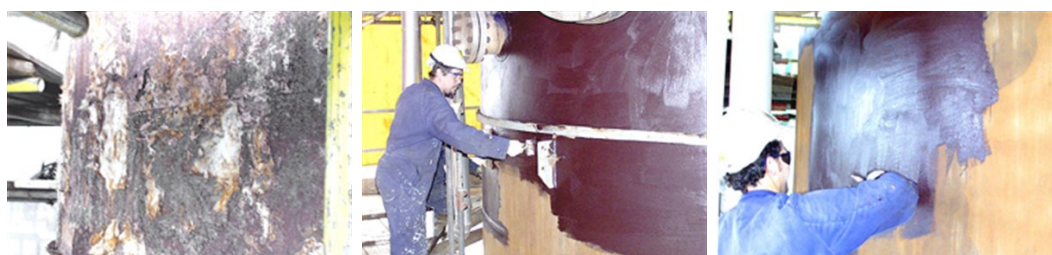
Photograph Descriptions

CUI (Corrosion Under Insulation) was causing costly shutdowns to under-take repairs.

* Prior to application, corrosion can easily be seen. Belzona® 5851 (HA-Barrier) is easily applied to hot surfaces by trowel, brush, or even spray. ,

Manual surface preparation was done with high pressure water blasting. Belzona® 5851 (HA-Barrier) was applied directly to hot pipework while in service.
