# CORRODED PIPEWORK: A THING OF THE PAST WITH BELZONA® 5851 (HA-BARRIER)

ID: 361

Customer Location: Oil refinery in New Zealand  
Application Date: 2001

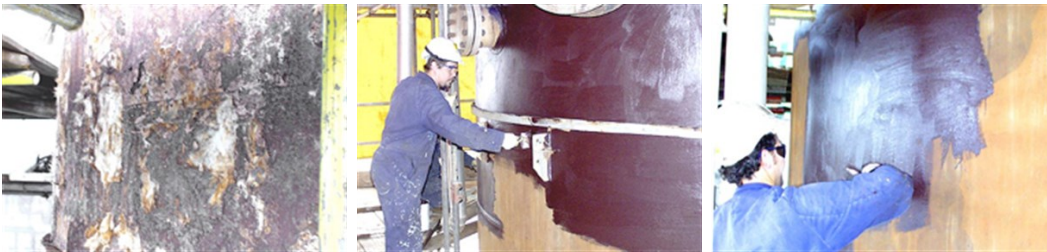
CUI (Corrosion Under Insulation) was causing costly shutdowns to under-take repairs.

\* Prior to application, corrosion can easily be seen. Belzona® 5851 (HA-Barrier) is easily applied to hot surfaces by trowel, brush, or even spray. ,

Corroded pipework and columns.

Manual surface preparation was done with high pressure water blasting. Belzona® 5851 (HA-Barrier) was applied directly to hot pipework while in service.
