CAR PARK REPAIRS WITH BELZONA

ID: 3619

Customer Location: Local authority, Blackpool, England

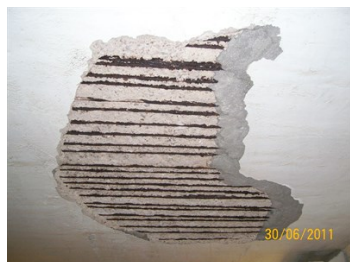
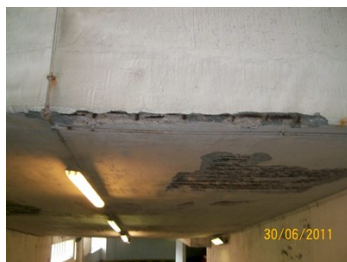
Carbonation of the reinforced concrete had led to extensive spalling on ceilings and walls, which required urgent repair.

* 1 & 2. Severe spalling on ceilings ,

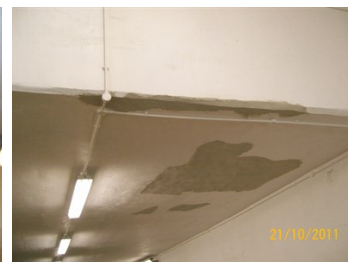
* 3 & 4. After: Belzona® 4141 applied to the overhead surfaces ,

The application was carried out in accordance with Belzona Know-How System Leaflet WPA-6.

The material's fast cure meant that the parking deck was reopened with minimum disruption and the repairs could be directly over-painted after just 3 days, which was the amount of time required to complete the concrete repair. The council selected Belzona as their first choice due to previous successful work undertaken for the council on another city car park.
