# CAR PARK REPAIRS WITH BELZONA

ID: 3619

Customer Location: *Local authority, Blackpool, England*  
Application Date: *October 2011*

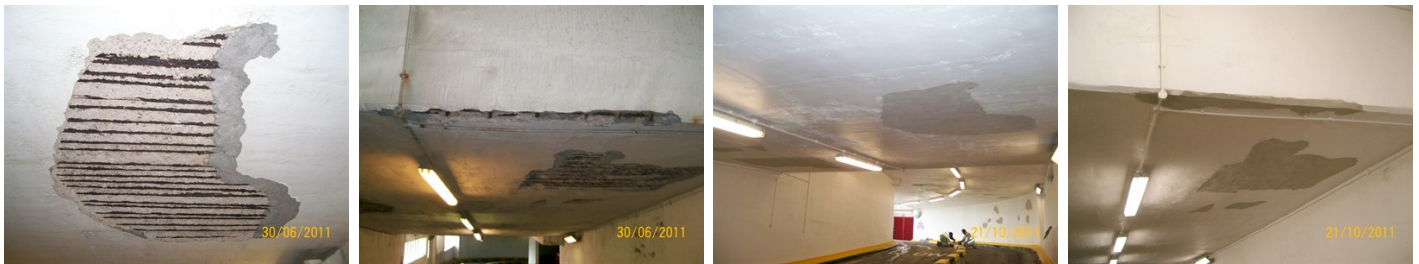
*Carbonation of the reinforced concrete had led to extensive spalling on ceilings and walls, which required urgent repair.*

- \* 1 & 2. Severe spalling on ceilings ,
- \* 3 & 4. After: Belzona® 4141 applied to the overhead surfaces ,

The application was carried out in accordance with Belzona Know-How System Leaflet WPA-6.

The material's fast cure meant that the parking deck was reopened with minimum disruption and the repairs could be directly over-painted after just 3 days, which was the amount of time required to complete the concrete repair. The council selected Belzona as their first choice due to previous successful work undertaken for the council on another city car park.
