# CLASSIC BELZONA PUMP REFURBISHMENT-OUTPUT INCREASES 9.5% AFTER 3½ YEARS

ID: 363

Application: CEP-Centrifugal Pumps

Two badly corroded/cavitated centrifugal KSB water supply pumps.

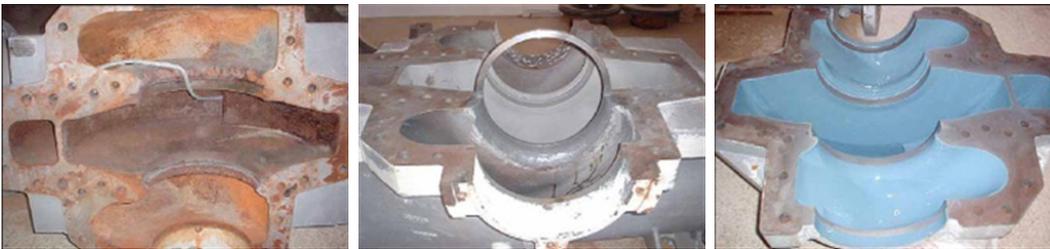
Output from the pumps was drastically reduced from the new condition due to corrosion and cavitation damage.

\* Damaged pump Neck ring seats restored to original sizes Complete repair Coating in good condition after 3-1/2 years of service ,

Application was carried out in accordance with Belzona System Leaflets CEP-2 and CEP-10.

Flow rate of New Pump - 540 L/sec (142 gal/sec) Flow rate of damaged pump - 480 L/sec (126 gal/sec) Flow rate of repaired pump - 540 L/sec (142 gal/sec), an increase of more than 12% over the corroded pump. After 3-1/2 years, the flow rate of the repaired pump is 530 L/sec (140 gal/sec), an increase of more than 9.5% over the corroded pump.
