# BUGSTRAHLGETRIEBE MIT BELZONA REPARIERT

ID: 3637

Standort des Kunden: *Lloyd Werft, Bremerhaven, Deutschland*  
Antragsdatum: *März 2011*

Winkelgetriebe des Bugstrahlruders eines Frachtschiffs.

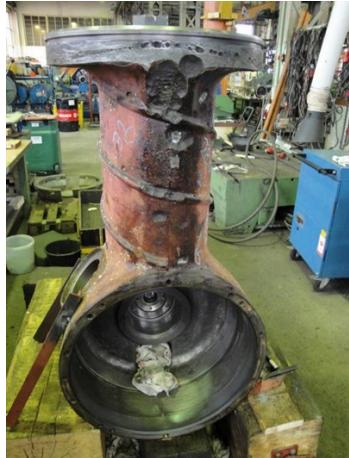
*Das Winkelgetriebe wies schwere Schäden am Gehäuse auf.*
