# BUGSTRAHLGETRIEBE MIT BELZONA REPARIERT

Industrie: Marine  
Anwendung: Schiffe und Offshore-Strukturen  
Substrat: Grauguss  
Produkte: \* Belzona 1311 (Ceramic R-Metal) ,  
\* Belzona 1321 (Ceramic S-Metal) ,  
\* Belzona 4311 (Magma CR1) ,

Standort des Kunden: Lloyd Werft, Bremerhaven, Deutschland  
Antragsdatum: März 2011

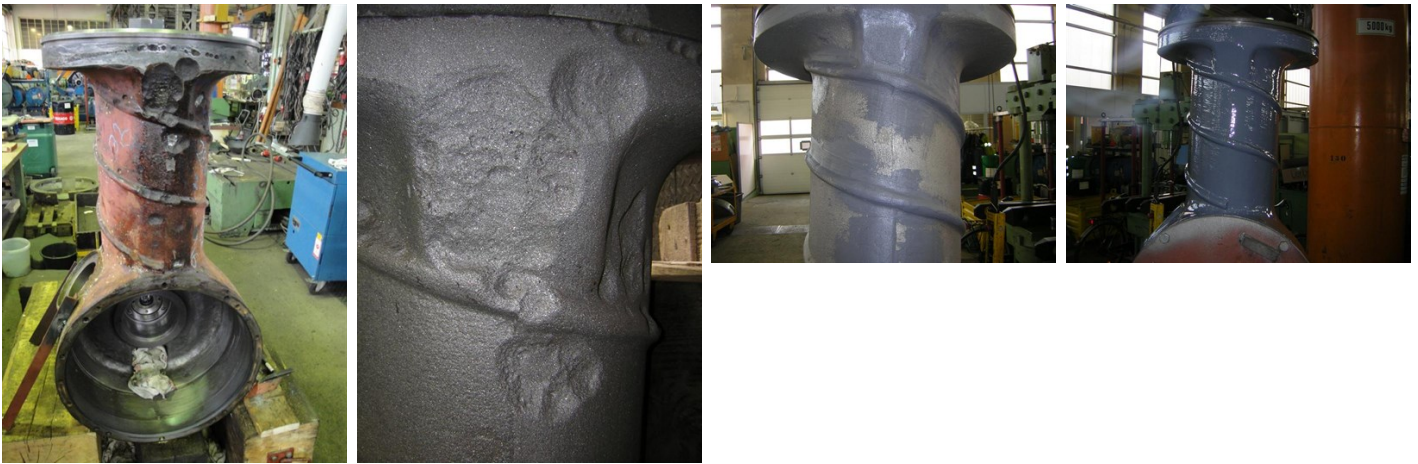
Das Winkelgetriebe wies schwere Schäden am Gehäuse auf.

- \* 1. Das Ausmaß der Schäden ist klar erkennbar ,
- \* 2. Nahaufnahme nach dem Sandstrahlen ,
- \* 3. Anwendung in Gang ,
- \* 4. Abgeschlossene Anwendung ,

Winkelgetriebe des Bugstrahlruders eines Frachtschiffs.

Die Anwendung wurde gemäß dem Belzona Know-how System Infoblatt SOS-2 durchgeführt.

Die Dockzeit betrug ca. 10 Tage, ein Ersatz war nicht möglich. Der Auftrag wurde dank guter Kontakte zur Werft und zur Reederei gewonnen.
