NEW BELZONA FLOOR SURFACE FOR WORKSHOP

ID: 364

Industry: General Industry
Application: FPA-Floor Problem Areas
Substrate: Concrete
Products: * Belzona® 4131 (Magma-Screed) ,

Customer Location: Engineering company in Portugal
Application Date: 2002

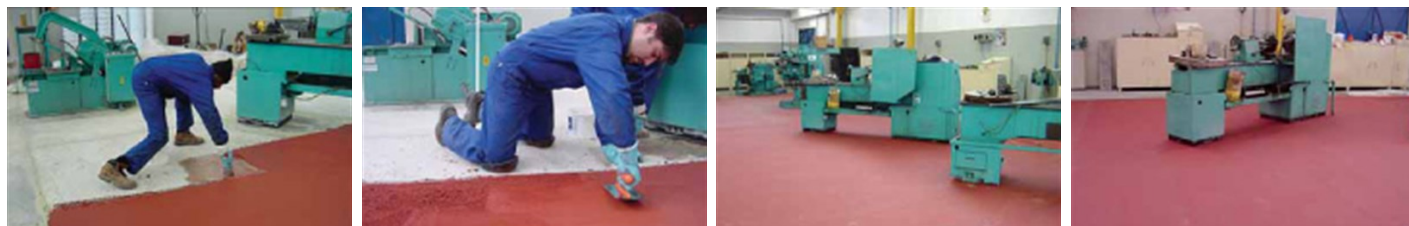
Photograph Descriptions

Previous floor coverings constantly failing and requiring regular maintenance. Floor cracked and generally in poor condition.

- * Belzona® 4911 (Magma TX Conditioner) being applied to ensure maximum adhesion ,
- * Application of Belzona® 4131 underway ,
- * Completed application ,
- * Another view of completed application ,

Application was carried out in accordance with Belzona System Leaflet FPA-1

Belzona® 4131 provides a tough impact and oil resistant surface.
