BELZONA REPAIRS BOW THRUSTER

ID: 3642

Industry: *Marine*
Application: *SOS-Ships and Offshore Structures*

Customer Location: *Shipyards, Bremerhaven, Germany*
Application Date: *March 2011*

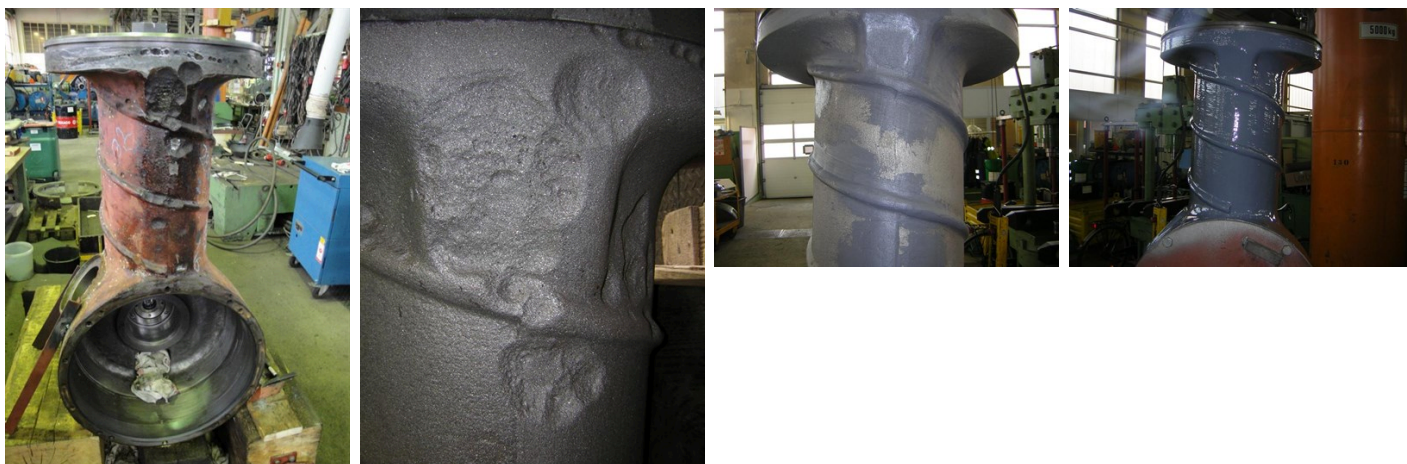
Photograph Descriptions

Extensive damage to the bevel gear system's casing.

- * Extensive damage clearly visible ,
- * Close-up following grit blasting ,
- * Application in progress ,
- * Completed application ,

Bow thruster casing of a cargo ship.

The application was carried out in accordance with Belzona Know-How System Leaflet SOS-2.

and reliable service delivery with the shipyard, shipping line and classification society. Belzona 4311 (Magma CR1) was applied not due to any chemical performance need but because the first inspection by the client is visual, and this extra layer gives a professional, aesthetical finish.
