BELZONA GRIP SYSTEM MAINTAINS BRAKE TEST EQUIPMENT

Customer Location: Truck test centre, central Sweden

Application Date: February 2012 (it has been done regularly since 2002)

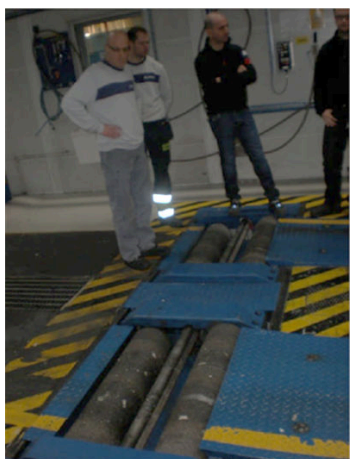
The drive rollers in the brake tester lose their grip and do not have sufficient friction with the tyre to complete an accurate test.

- * Worn rollers in the truck tester ,
- * Close-up of the worn roller ,
- * Roller coated with Grip system of Belzona® 1321 and Silicon carbide aggregate, in the workshop ,
- * Finished application ,
