# BELZONA REPAIR & PROTECTION OF FRANCIS TURBINE RUNNERS

Customer Location: Hydroelectric power plant, Barcelona, Spain

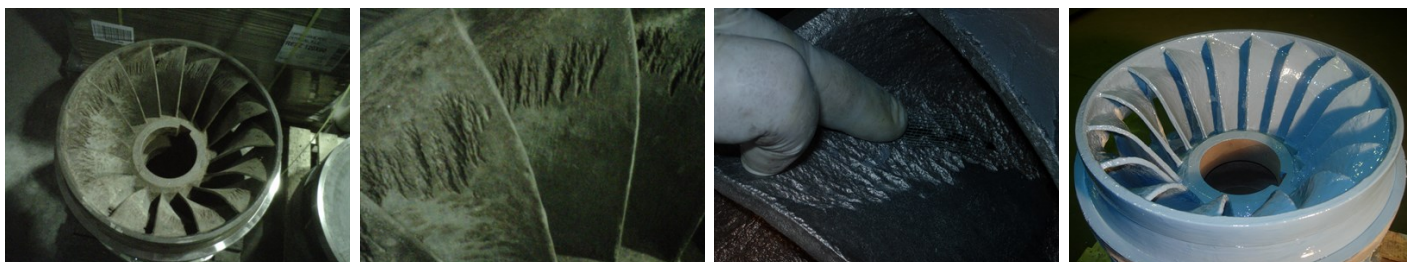
The turbines were suffering from corrosion and erosion cavitation damage in the runner blades which caused holes.

\* Damaged turbine Close-up of the damage Belzona® 1111 used in combination with a metallic mesh Application completed with Belzona® 1341 ,

The application was carried out in accordance with the Belzona Know-How System Leaflets CEP-1, CEP-3 and CEP-5. Firstly, the holes and metal losses were repaired with Belzona® 1111 combined with a metallic mesh to bridge and strengthen the holed areas. Once the damaged areas had been repaired, the turbine runners were completely coated with Belzona® 1341.
