# BELZONA PROTECTION TO AERZENER LOBE COMPRESSOR

ID: 365

Customer Location: Steel Mill in Saudi Arabia  
Application Date: 2002

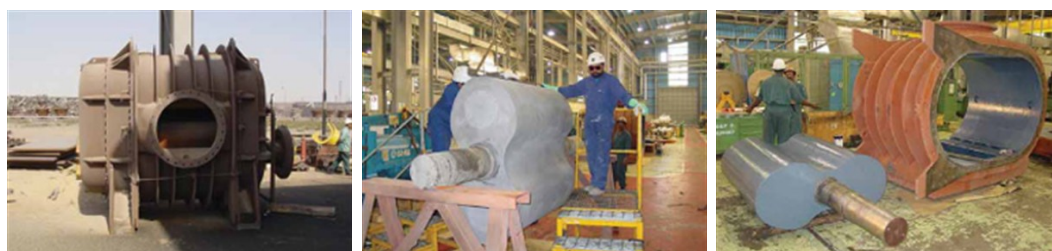
## Photograph Descriptions

Hot scrubbed gas contains fine particles which are broken down by spraying with water, this combination causes severe corrosion.

- \* General view of compressor ,
- \* Work underway on the lobe ,
- \* Body and lobe protected with Belzona® 1391 ,

Application was carried out using a modified version of Belzona System Leaflets PDP-4, FBC-2 and FBC-5. Pitting damage repaired with Belzona® 1111 and internal casing and lobe protected with Belzona® 1391.
