BELZONA PROTECTS PLATFORM LEG

Application: SOS-Ships and Offshore Structures

Customer Location: Offshore oil platform, Tianjin-China.

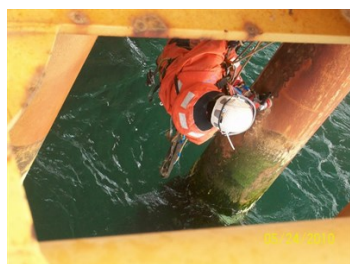
Surface Preparation by MBX
Bristle Baster

Application was carried out in accordance with Belzona Know-How System Leaflets SOS-20a and SOS-20b. The surface was prepared as thoroughly as possible with an MBX Bristle Blaster being used above the water line. The surface preparation and application of Belzona® 1161 had to be carried out using rope access and divers.

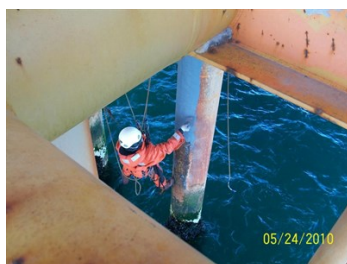
Belzona 1161 being applied

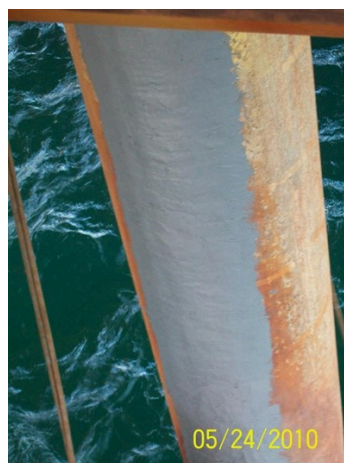
Completed Application

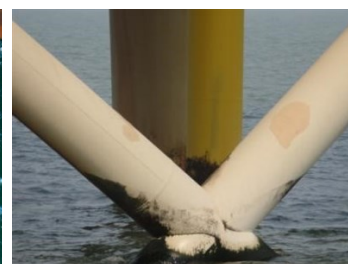
Inspection after 7 years in
service

The surface tolerant properties of Belzona® 5831 made it the ideal solution for these difficult access conditions. The product provides excellent adhesion to surfaces both in the splash zone and underwater. Application inspected in 2017 after seven years in service and found to be providing excellent corrosion protection.
