BIG SAVINGS WITH BELZONA'S UNCONVENTIONAL REPAIR TECHNIQUES

ID: 372

Customer Location: *Petrochemical facility - Minnesota, U.S.A.*
Application Date: *June 2001*

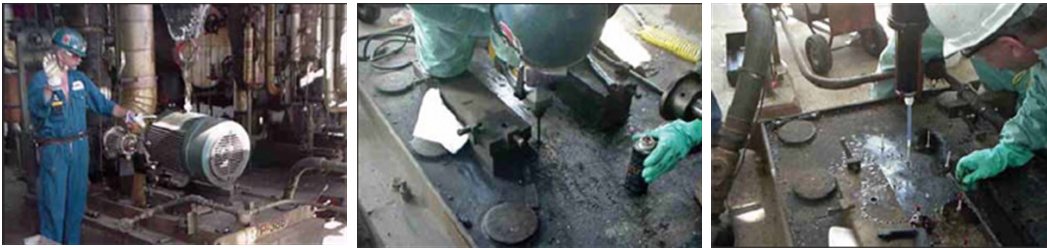
Photograph Descriptions

Hollow spots under pump base between the grout and the steel base created vibration, thereby causing pre-mature bearing failure.

- * Removal of pump from base ,
- * Installing injection ports ,
- * Injecting with gun ,

The Application was carried out in accordance with a modified version of Belzona Know-How Systems leaflet GSS-9. Injection Method: Product placed in pneumatic gun, injected using static mixer.
