# BELZONA AIR HANDLING FAN & SHROUD

ID: 373

Application: *FBC-Fans, Blowers and Compressors*

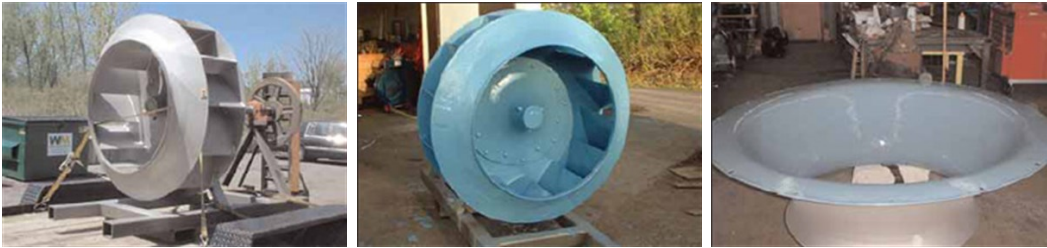
## Photograph Descriptions

*Fan was constantly going out of balance due to particulate sticking to the blade.*

- \* Fan blasted to 3-4 mil profile, white metal finish ,
- \* Second coat of Belzona® 1341 completed on fan ,
- \* Shroud coat completed ,

The Application was carried out in accordance with Belzona Know-How System Leaflet FBC-2.

The fan was dynamically balanced before and after the application.
