# BELZONA EXCELS WHERE OTHERS FAIL!

ID: 375

Forging Machine Cam

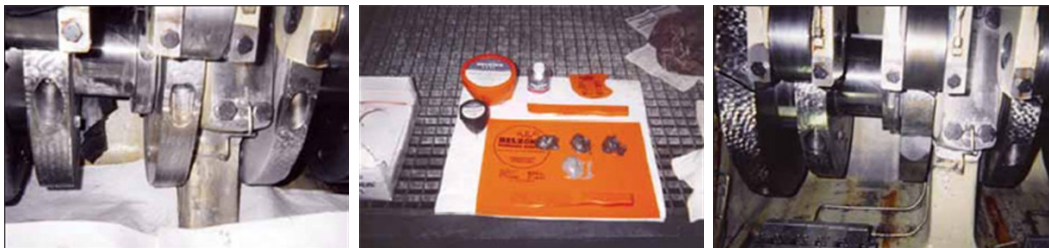
Forging machine cam failed, imitator product failed in one week.

- \* The Cam ,
- \* Products being used ,
- \* The completed application ,

The application was carried out in accordance with a modified version of Belzona Know-How Systems Leaflet MPT-12. Damaged areas were ground down. Following degreasing, Belzona® 1111 was applied, then ground/sanded back to profile.

Application saved tens of thousands of dollars in downtime, as disassembly of machine takes four days. Four months in service - PERFECT!
