BELZONA TACKLES 98% SULFURIC ACID TANK

ID: 376

Customer Location: *Power Plant in Alabama - U.S.A.*
Application Date: *February 2003*

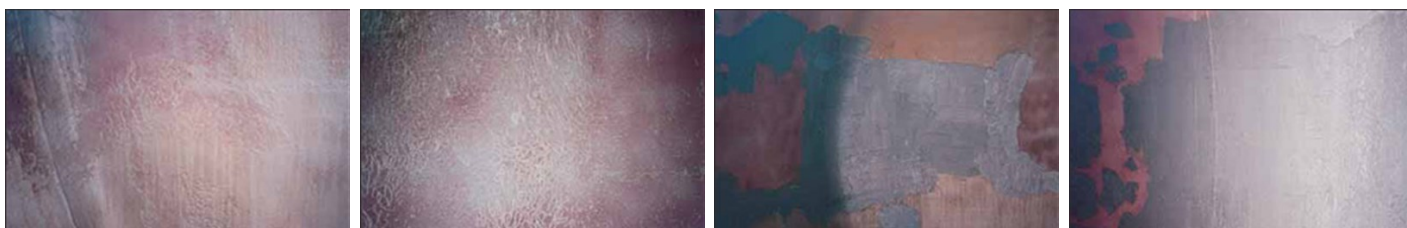
Photograph Descriptions

Tank coating had failed, leading to severe pitting.

- * 1. & 2. Before ,
- * 3. & 4. After ,

98% Sulfuric acid tank interior.

The application was carried out in accordance with Belzona Know-How Systems leaflet TCC-5. After the tank was neutralized, it was blasted to a near white metal finish.
