# BELZONA REPAIRS AND PROTECTS AUTO REPAIR SHOP FLOOR

ID: 377

Application: *FPA-Floor Problem Areas*

Substrate: *Concrete*

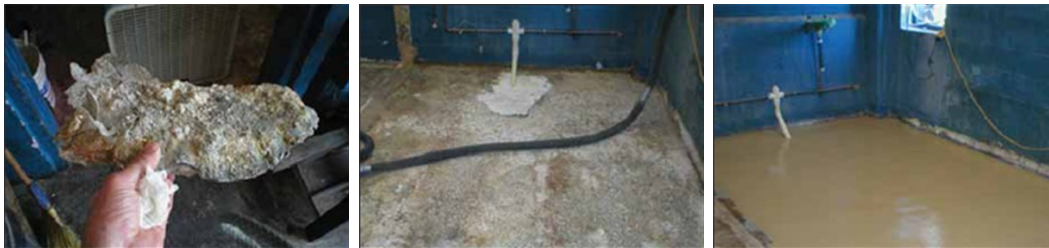
*Floor area damaged due to exposure to sulfuric acid.*

- \* Prior to application ,
- \* Prepared floor ,
- \* Belzona® 4131 (Magma-Screed) and Belzona® 5811 (Immersion-Grade) applied to protect application area long term ,

The application was carried out in accordance with Belzona Know-How System Leaflets FPA-1 and TCC-15.

The facility is over 30 years old and the customer had made several attempts to repair the floor. In each case, they used some type of concrete repair products to make the repair and coat with several types of paint. Each method was more expensive than the Belzona repair and none were effective.
