# BELZONA REPAIRS AND PROTECTS AUTO REPAIR SHOP FLOOR

ID: 377

Customer Location: Auto Repair Center in Northern Florida - U.S.A.

Application: FPA-Floor Problem Areas

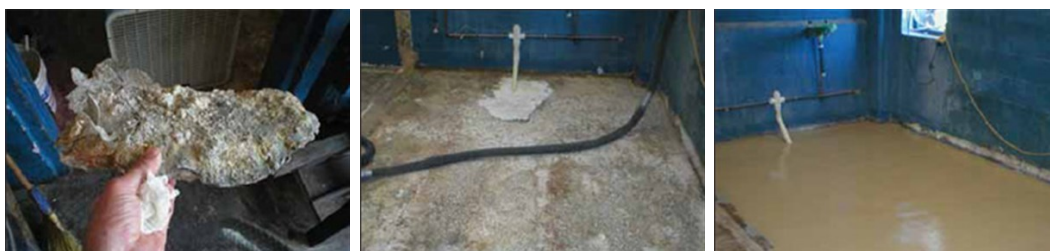
## Photograph Descriptions

Floor area damaged due to exposure to sulfuric acid.

- \* Prior to application ,
- \* Prepared floor ,
- \* Belzona® 4131 (Magma-Screed) and Belzona® 5811 (Immersion-Grade) applied to protect application area long term ,

The application was carried out in accordance with Belzona Know-How System Leaflets FPA-1 and TCC-15.

The facility is over 30 years old and the customer had made several attempts to repair the floor. In each case, they used some type of concrete repair products to make the repair and coat with several types of paint. Each method was more expensive than the Belzona repair and none were effective.
