# BELZONA 4000 SERIES FLOOR COATING FOR A STERILIZING ROOM

Customer Location: Medical Sanitizers - Minnesota U.S.A.  
Application Date: March 2002

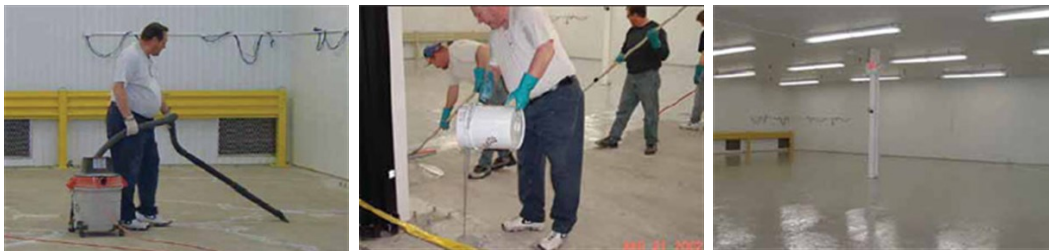
## Photograph Descriptions

Floor was spalled, cracked and and therefore non-compliant with sanitary requirements.

- \* Final steps of surface preparation ,
- \* In progress ,
- \* Job complete ,

The application was carried out in accordance with a modified version of Belzona Know-How System Leaflet FPA-3. Shot-blasted floor, followed by thorough cleaning. Roller/brush application of product in a slurry-grade.
