BELZONA UPGRADES HOSPITAL ROOF

ID: 3866

Customer Location: *Hospital, UK*
Application Date: *April 2011*

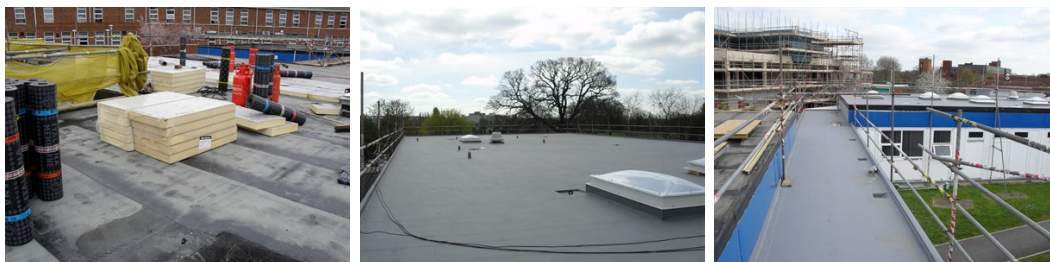
Photograph Descriptions

- * Insulation boards ready for installation on the deteriorated roof ,
- * First coat of Belzona® 3111 applied ,
- * Completed application ,

Large hospital roof which had deteriorated through weathering

Application was carried out in accordance with Belzona Know-How System Leaflet RPA-8. After installing insulation boards overlaid with felt, a fully reinforced Belzona® 3111 system was applied.
