SPALLED CONCRETE VAULTS ARE RECONSTRUCTED WITH BELZONA

Customer Location: Natural Gas Processing Plant in New Mexico, U.S.A.

Application: TCC-Tanks and Chemical Containment Areas

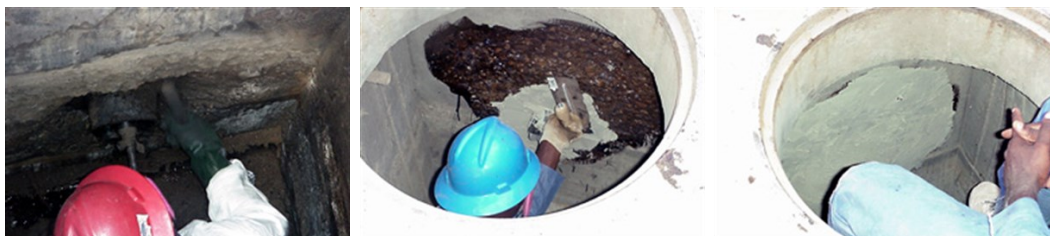
Photograph Descriptions

Over the years the different thermal expansion characteristics of the pipes caused the concrete surrounding pipes in the vault to spall.

- * Some of the spalls were 8 inches deep ,
- * Belzona® 4911 applied, application of Belzona® 4141 in progress ,
- * Admiring the reconstructed unit ,

The application was carried out in accordance with Belzona Know-How System Leaflet TCC-9.
