# REFURBISHMENT OF LARGE DIFFUSER PUMPS WITH BELZONA

ID: 3887

Customer Location: Power station, Northern Ireland  
Application Date: 2010

Two 48" cooling water circulating pumps

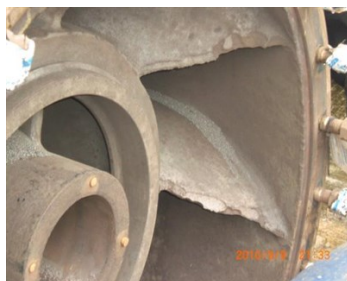
The pumps, each weighing over eleven tonnes without the motor, were failing to deliver sufficient flow to satisfy customer demand.

- \* One of the diffuser pumps after disassembly ,
- \* Degree of damage clearly evident on the diffuser vanes ,
- \* Coated diffuser vanes ,
- \* Coating of the pump internals and bell mouth with Belzona® 1341 and Belzona® 5811 externally ,

Application was carried out in accordance with Belzona Know-How System Leaflets CEP-1, 3, 4 & 5.

After refurbishment, the pumps were returned to the power station, where they were installed, aligned and commissioned. Both pumps were returned to service within an eight week period and within budget. The customer has expressed his great satisfaction with the service provided and is already reaping the benefits of the newly coated pumps.
