BELZONA PROTECTS PIPELINE FROM MILLSCALE WEAR

Industry: *General Industry*
 Application: *VPF-Valves, Pipes and Fittings*
 Substrate: *Steel*
 Products: ** Belzona® 4111 (Magma-Quartz),*

Customer Location: *Steel plant, South of France*
 Application Date: *September 1990*

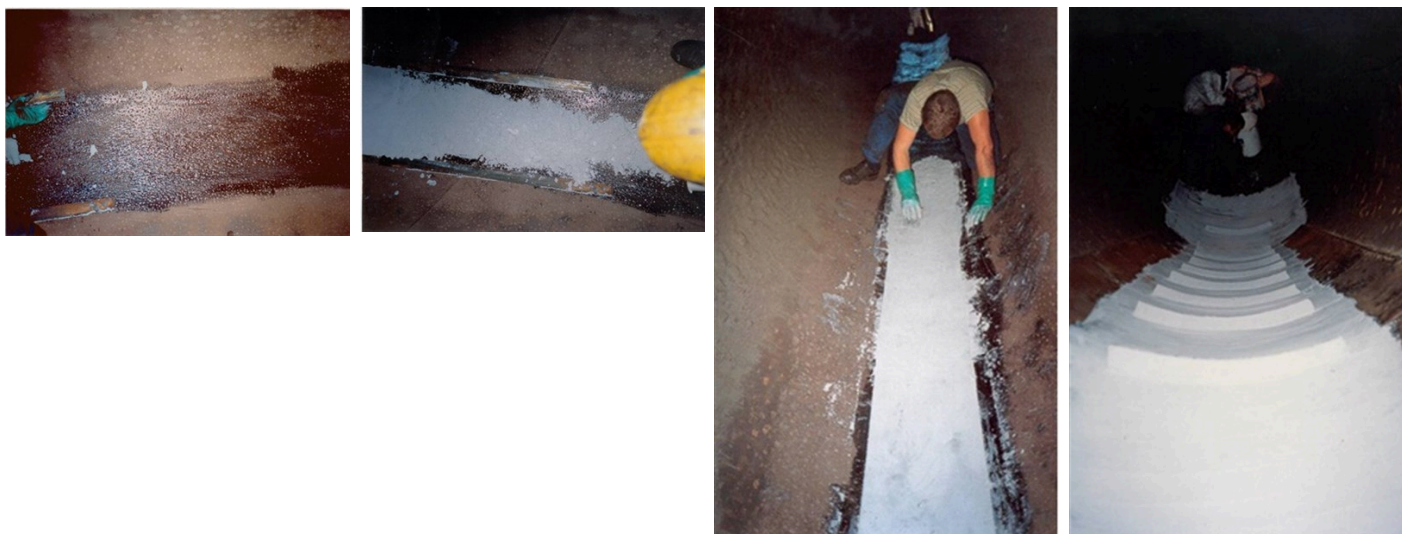
Corrosion and erosion in the lower third of the pipeline caused by abrasion from the millscale .

- * Application of Belzona® 4911 after gritblasting the substrate ,
- * Beginning the application of Belzona® 4111 ,
- * Application in progress ,
- * Creating steps with Belzona® 4111 on a sloping area of the pipeline, in order to facilitate the inspection ,

The application was carried out in accordance with Belzona Know-How System Leaflet VPF-2.

Following a trial over several months, competing with an alternative solution (which did not last), Belzona 4111 was chosen to protect the lower sections of the pipeline. Its fast cure speed reduced the repair duration. The application was carried out over 5 years: 100m/year (45 buckets/year). After the inspections carried out in 2000, 2001 and in 2002, the product is still in perfect condition. To aid access/application steps were created with Belzona 4111 in a skloping section of the pipeline.
