# BELZONA REPAIRS FUELING HOSES

ID: 39

Industry: *Marine*  
Application: *SOS-Ships and Offshore Structures*

Customer Location: *Ship bunkering (fueling) company, U.S.A.*  
Application Date: *March 1999*

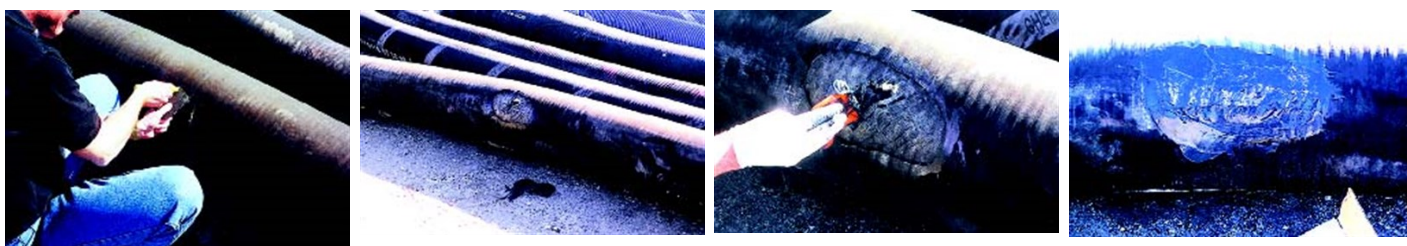
*Bunkering hose outer skin damaged, potentially weakening the hose. A rupture could be catastrophic in terms of the environment and safety.*

- \* Damaged section removed ,
- \* Damaged area after conditioning ,
- \* Applying Belzona® 2211 (MP Hi-Build Elastomer) ,
- \* Finished application is ready for service ,

Application was carried out out in accordance with Belzona Know-How Leaflet SOS-12.
