BELZONA REPAIRS FUELING HOSES

ID: 39

Industry: *Marine*
Application: *SOS-Ships and Offshore Structures*

Customer Location: *Ship bunkering (fueling) company, U.S.A.*
Application Date: *March 1999*

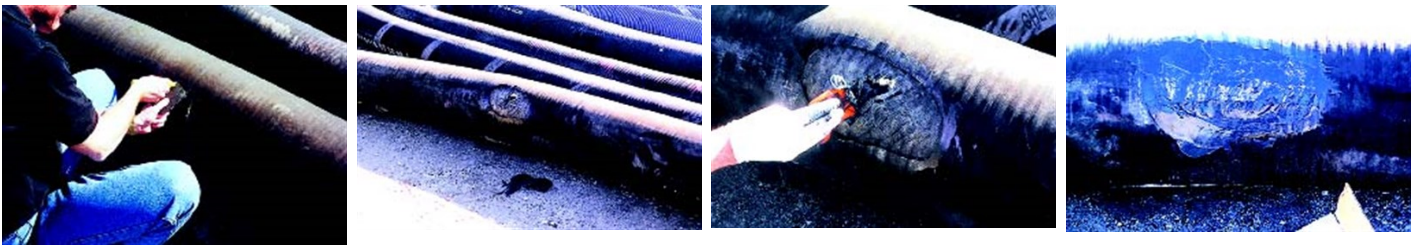
Photograph Descriptions

Bunkering hose outer skin damaged, potentially weakening the hose. A rupture could be catastrophic in terms of the environment and safety.

- * Damaged section removed ,
- * Damaged area after conditioning ,
- * Applying Belzona® 2211 (MP Hi-Build Elastomer) ,
- * Finished application is ready for service ,

Application was carried out out in accordance with Belzona Know-How Leaflet SOS-12.
