SLOPED SURFACE MADE SAFE WITH BELZONA

ID: 390

Application: FPA-Floor Problem Areas

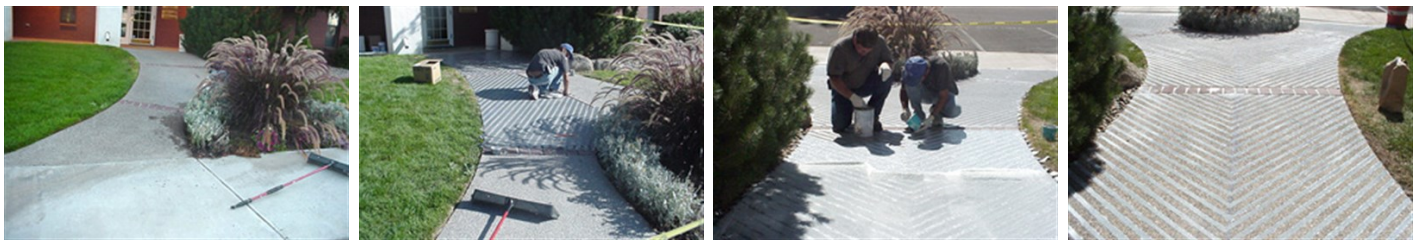
Photograph Descriptions

Sloped walkway with exposed aggregate became very slippery when wet, creating a safety hazard.

- * The slope walkway entrance was very slippery when wet. ,
- * The pattern is created as tape is being laid. ,
- * Application of the Belzona® Non-Slip System in progress. ,
- * The finished non-slip system; the pedestrian area is made safe. ,

The non-slip system remains in perfect condition after several years. The potential for slippage is alleviated.
