# THE LIFE EXPECTANCY OF ANOTHER PUMP IS EXTENDED SIGNIFICANTLY WITH BELZONA

Customer Location: Coal Fired Power Plant in New Mexico, U.S.A.

Application: CEP-Centrifugal Pumps

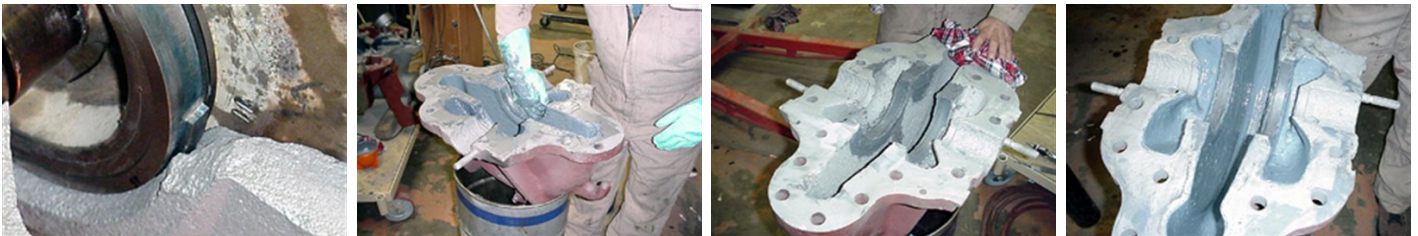
The pump was badly worn and the case ring landings were completely eroded.

- \* Sever erosion of the case ring landings ,
- \* Application in progress ,
- \* Casing wear ring seats rebuilt ,
- \* The pump casing is completely refurbished ,

The application was carried out in accordance with Belzona Know-How System Leaflets CEP-2, CEP-3 and CEP-5.

Prior to the Belzona application, the life expectancy of this pump was between six months and one year. Two years after the first application the pump is still pumping at peak efficiency. The pump has performed so well that the utility decided to refurbish another pump in early 2003.
