# Reconstrucción clásica de bomba con Belzona

ID: 3936

Solicitud: *Bombas centrífugas*

Ubicación del cliente: *Fabricante de cobre, Bélgica*

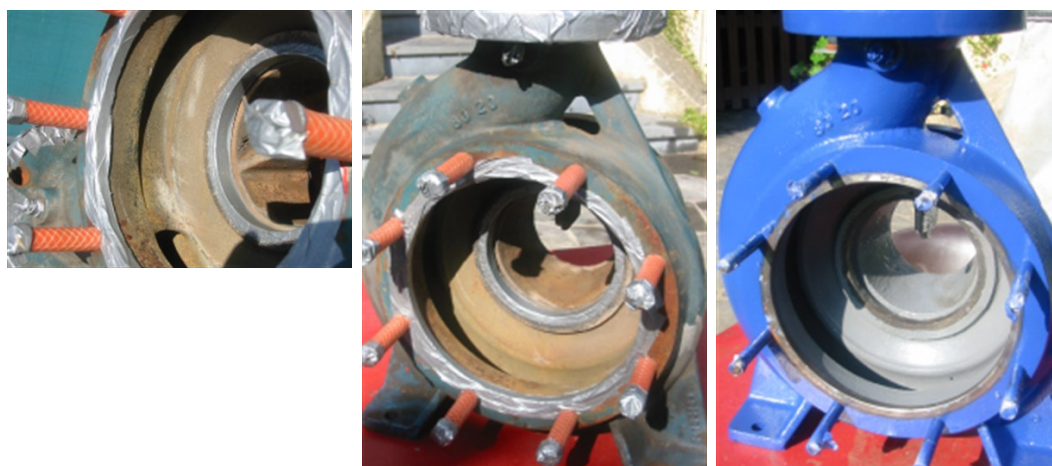
*El flujo de agua constante en la bomba produjo erosión/corrosión en partes críticas de la carcasa.*

- \* Reconstrucción de perfiles ,
- \* Otra vista de los perfiles ,
- \* Aplicación finalizada ,

Carcasa de bomba

La aplicación se realizó de acuerdo con los folletos Belzona de Sistema Know-How CEP-1 y CEP-5.
