BELZONA REPAIRS TO FLOATING HOSE

ID: 396

Industry: Oil & Gas
Application: SOS-Ships and Offshore Structures

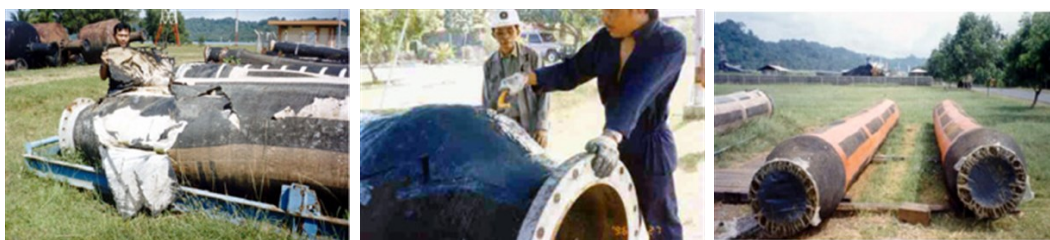
Photograph Descriptions

Extensive damage to the rubber flotation.

- * The extent of the damage clearly evident. ,
- * Application of Belzona® 2221. ,
- * Completed application. ,

Application was carried out in accordance with a modified version of Belzona Know-How System Leaflet SOS-12.

Inspected February 2000 hose still in good condition. Repair cost \$3,000; new hose cost about \$70,000.
