BELZONA UPGRADES SAFETY AND APPEARANCE OF SCHOOL ENTRANCE

Customer Location: Secondary School, Port Talbot, South Wales

Application: FPA-Floor Problem Areas

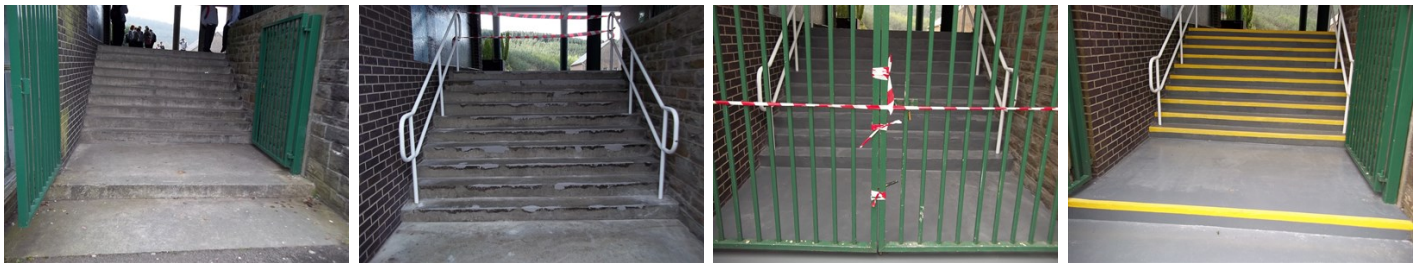
Photograph Descriptions

Step nosings had become damaged and overall very dirty. The school wanted the main entrance upgrading and wanted to ensure the steps were safe for its staff, pupils and visitors.

- * Deteriorating steps at the entrance to the school ,
- * Repair to steps using Belzona® 4111 ,
- * Application of Belzona® 5231 overall ,
- * Complete repair with Belzona® 4411 grip system applied to the step nosings. ,

Application was carried out in accordance with Belzona System Leaflets FPA-1 and FPA-8. The concrete step nosings were repaired using Belzona® 4111 before coating with Belzona® 5231. Finally a Belzona® 4411 grip system was applied to step nosings.
